# **Condition/Failure Analysis and Rehabilitation Prioritization of Sanitary Collection System**

## **Infrastructure Asset Management Alberta (IAMA) Workshop**

**Presented by:**  
**Nawaz Panhwer, P.Eng**  
**Infrastructure Manager**

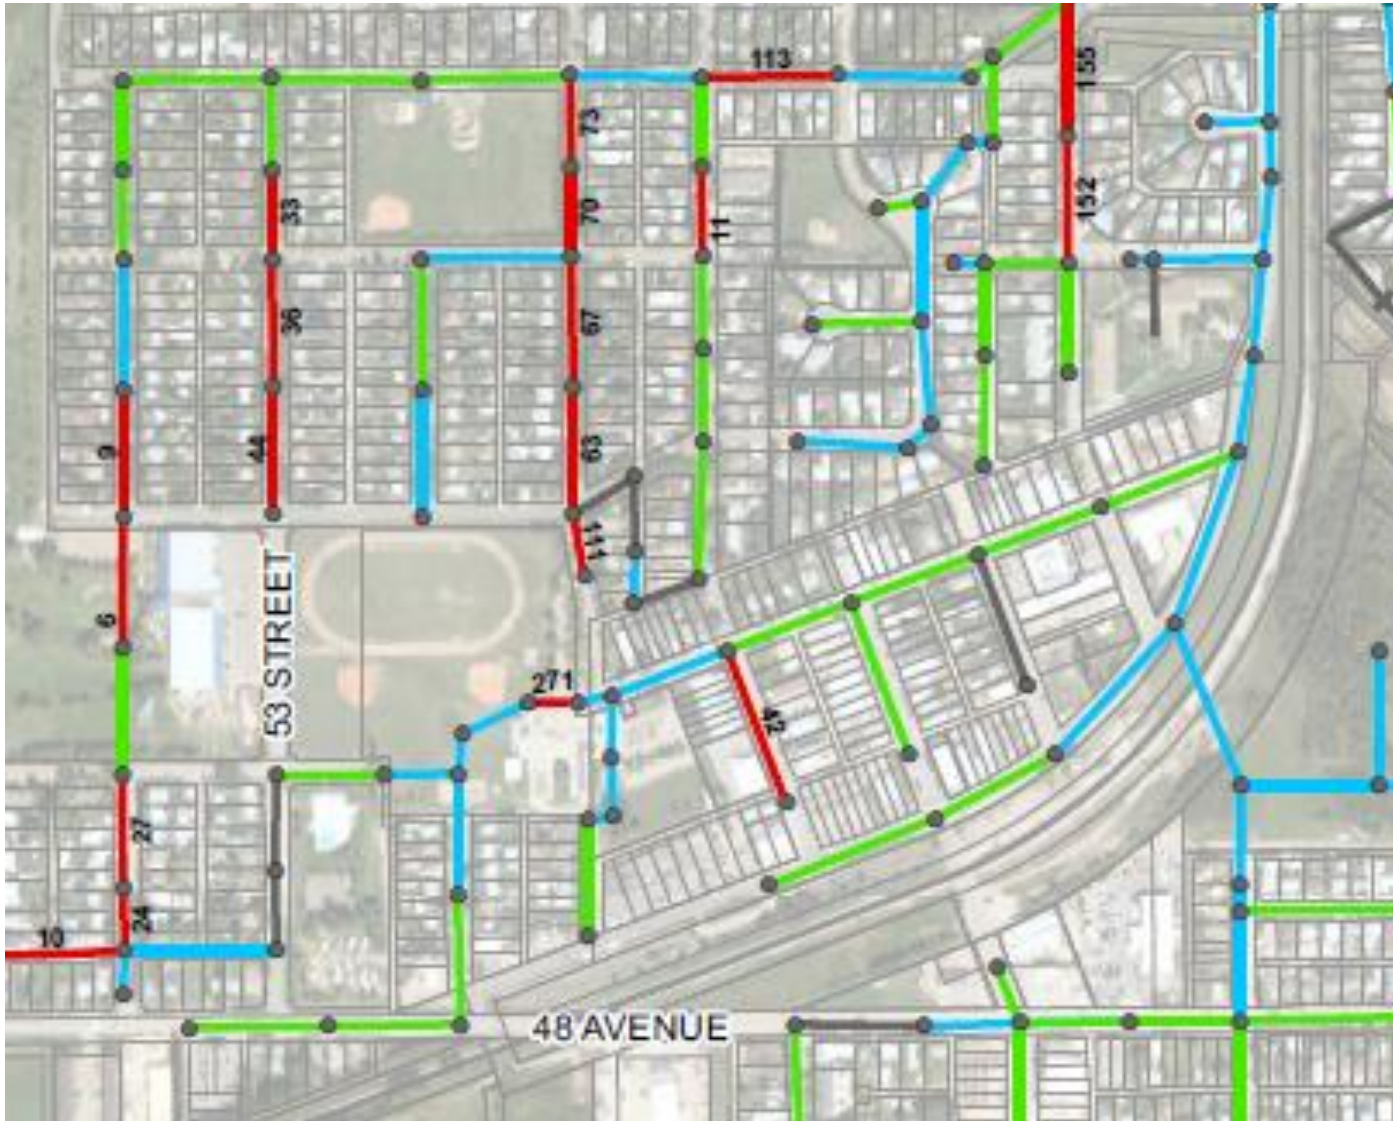
# CCTV WEIGHTED PROBABILITY SCORES

## Sanitary CCTV Weighted Probability Score

- $\geq 0.5$
- 0.41 - 0.49
- 0.21 - 0.40
- No Structural Defects Reported
- Not Inspected
- Sanitary Manhole
- 11 Inspection ID
