Case Study: Transportation Asset Management

Roads and Sidewalks in St. Albert

Brett Newstead P.Eng, M.Sc, PMP Transportation Infrastructure Engineer *City of St. Albert*

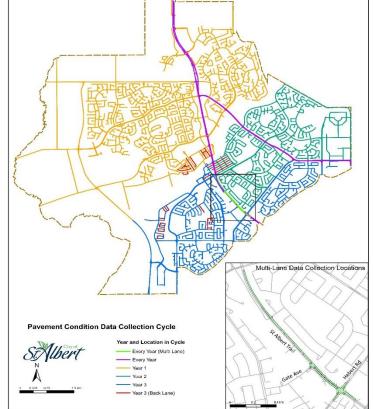
The City has a consultant collect data across
the City in thirds

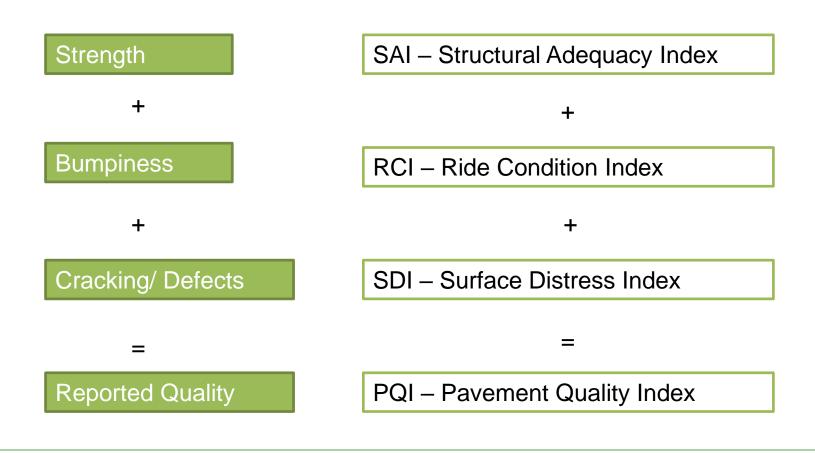
Quality Metrics

- This data that is collected is loaded by the consultant into the City's system.
- The resulting data is analyzed to produce 3 different indicators and one over all quality index

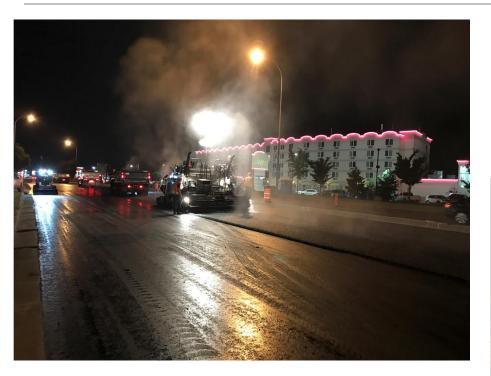
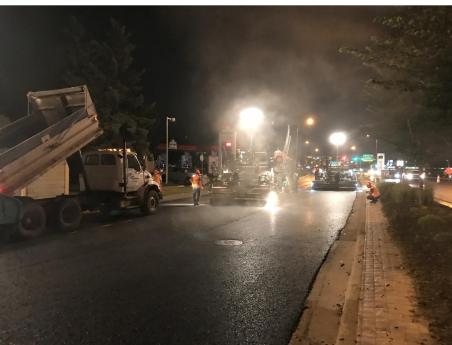
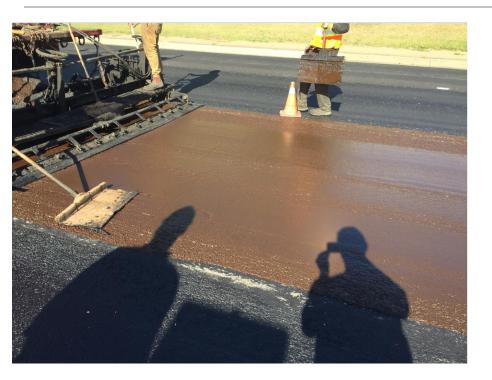
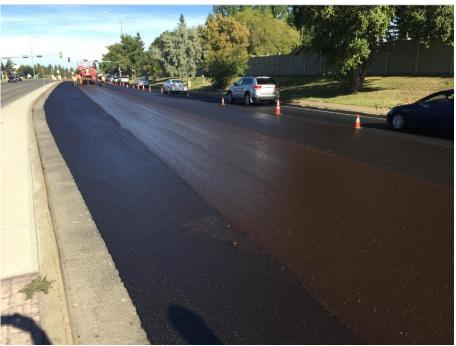
Multi Lane Condition Assessment Results [4]

- Condition Results
- The following results show the PQI, RCI, SDI before and after

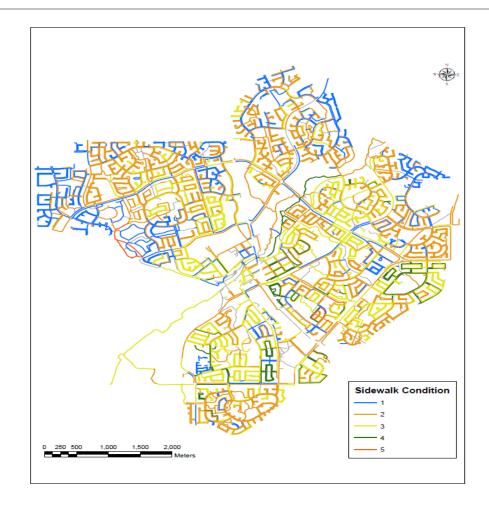
2011 Sidewalk Assessment Sections

- The City of St. Albert began doing complete assessments of it's sidewalks in 2011.
 - Hired a consultant to assess the network
 - Consultant provided background on issues that were collected
 - Result was a map of City and it's sidewalk conditions
 - Assessment took 2 months and collected 11,000 points

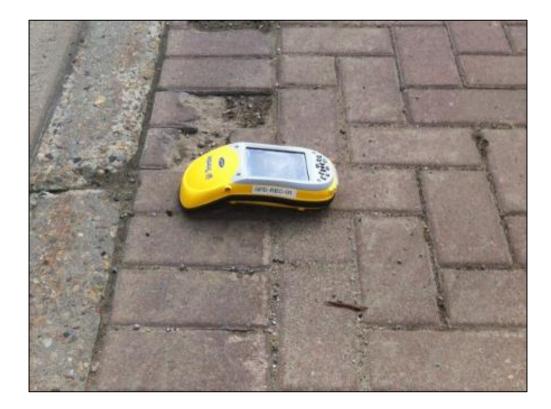
Figure 8: Sample Photo of Data Collector (2013)

- In 2013, the City opted to develop their own internal guidelines and data collection methods
 - Would help develop consistency in rating across organization
 - Create an in-house knowledge set
 - Done using previously purchased "off the shelf" technology and software

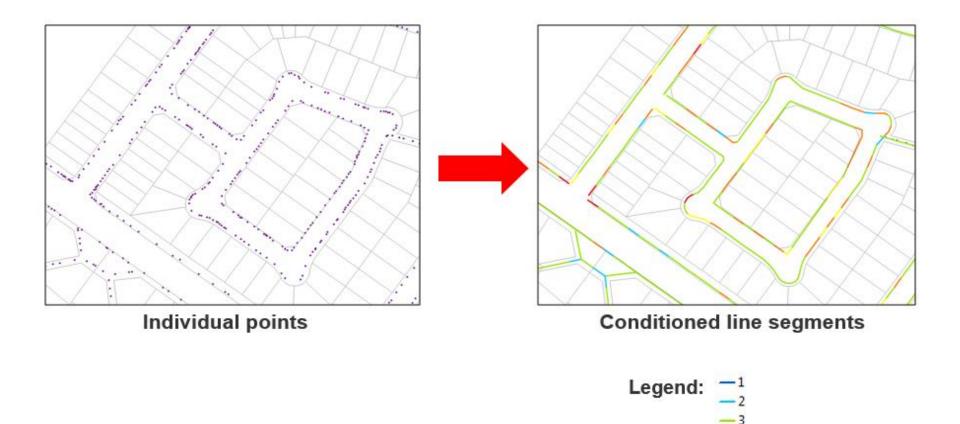
- Analysis
 - 10 meter sidewalk segments (6 panels)
 - Points grouped by nearest 10 meter segment
 - ArcMap points transferred to Excel
 - Algorithms condition rate (1-5) the segments

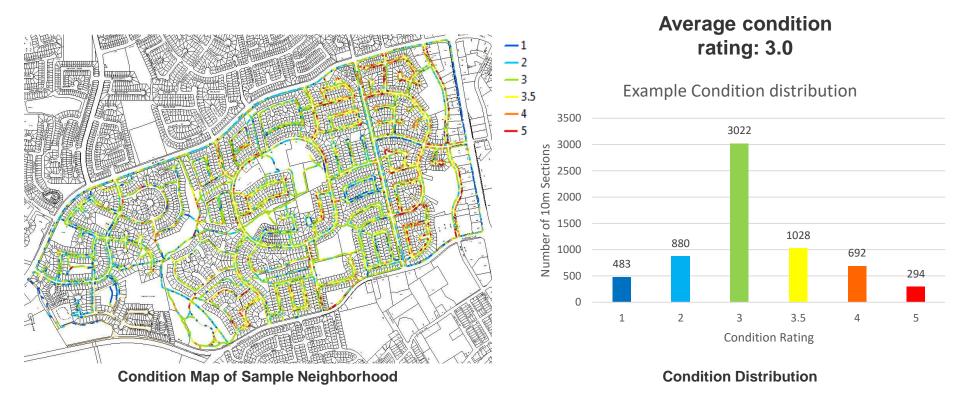
Sample Neighborhood

- The following are sample results of what the City can now export in detail:
 - Overall Neighborhood Statistics
 - Overall City Condition Map
 - Trip Hazard Maps
 - Google Earth Files

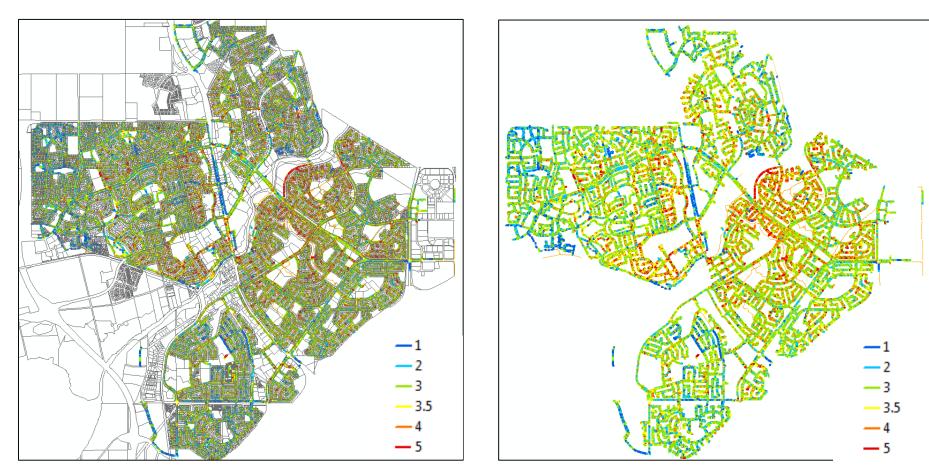
Condition rating of St. Albert with parcels

Condition rating of St. Albert excluding parcels

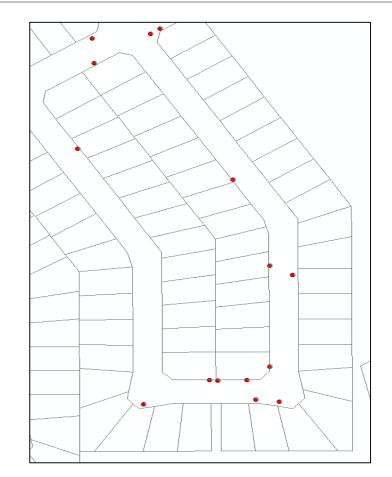
Trip hazards in a neighborhood

- Number of shaveable trip hazards: 1013
- Number of trip hazards: 2035
- Percentage of shave-able trip hazards: 49.8%
